**CONRINA
REMEDIAL
BUILDING
SOLUTIONS**

GLEBE RESIDENCE

Scope of works:

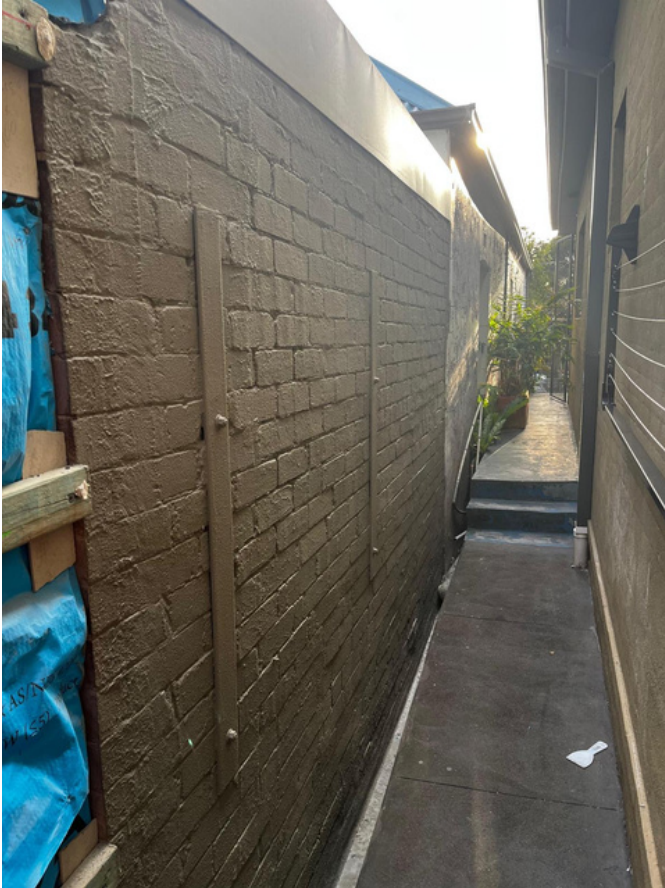
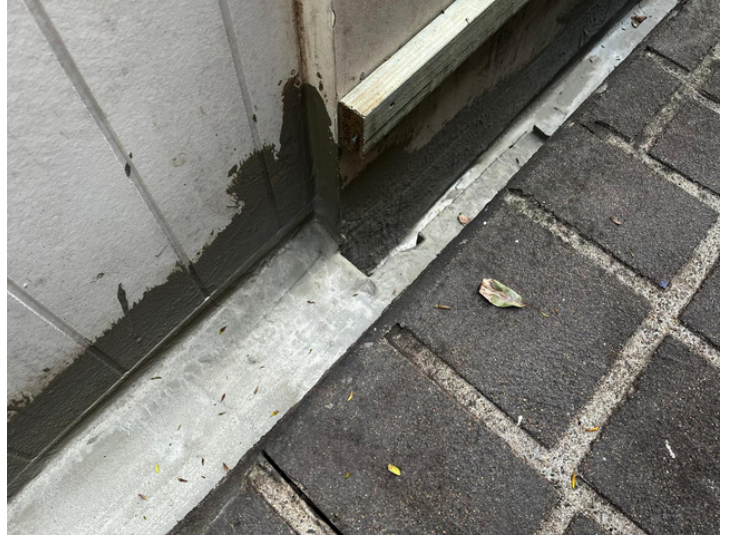
- Identify a water leak.
- Conduct water test.
- Develop repair methodology.
- Introduce external membrane and drain at base of walls as residence floor below external level.
- Remove peeling paint and apply waterproof skim coat.
